T-1000/optimail™ Ribbon Repair Instructions

As you may know, the cassette housings of the T-1000 and optimail™ are now manufactured in such a way that opening the housing is not possible. This becomes an issue when a customer needs to repair a torn ribbon. Below are steps for an easy fix to overcome that problem.

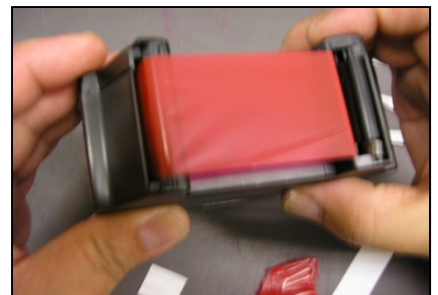
Step 6: Tighten the ribbon using the winding roller until the repaired section of ribbon is fully inside the cartridge.
